PHASE I ENVIRONMENTAL SITE ASSESSMENT

Prepared For:
K&C Oilfield Hauling Ltd.

Property Description:
Lot 9, Block 1, Plan 082 6486
Lot 6, Block 1, Plan 852 1590
Vermilion River, AB

Project Number:
110-1820

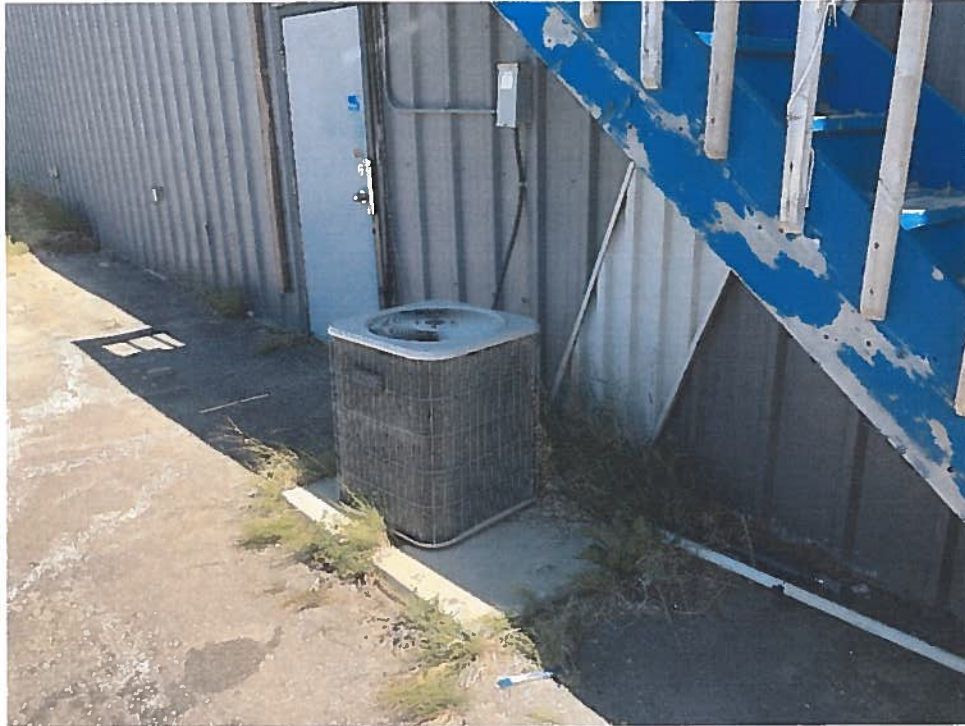
FIGURE 8: EXTERIOR AC UNIT

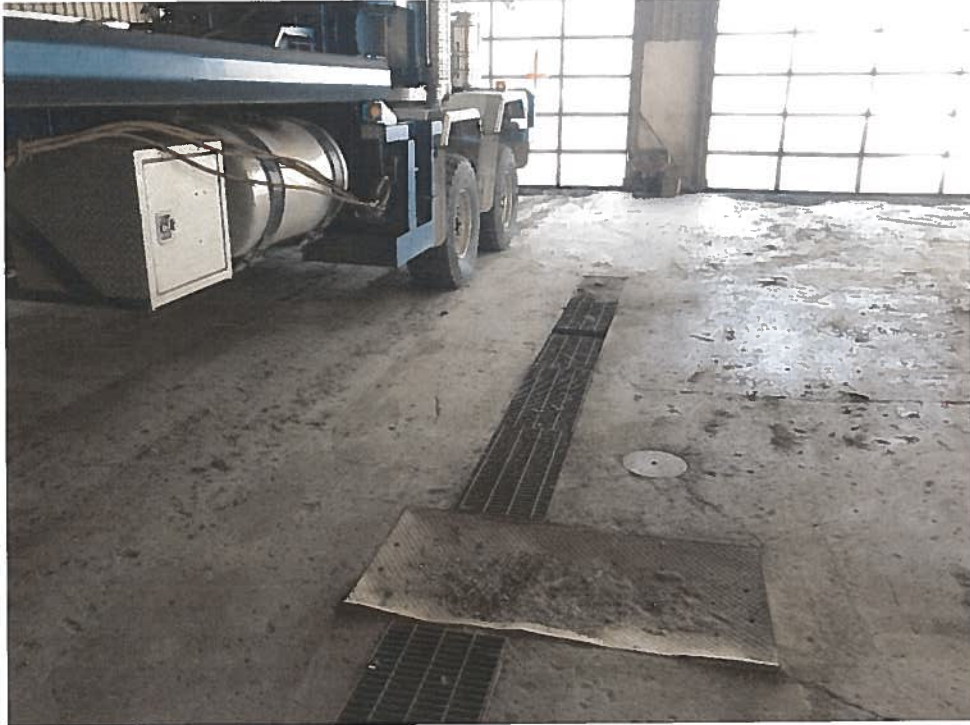
- Floor Drains
2 floor drains/sumps were observed in the shop warehouse area. These drains collected material from inside the building and are drained to an outside tank that is emptied and disposed of as required.

FIGURE 12: SUMP IN SHOP AREA

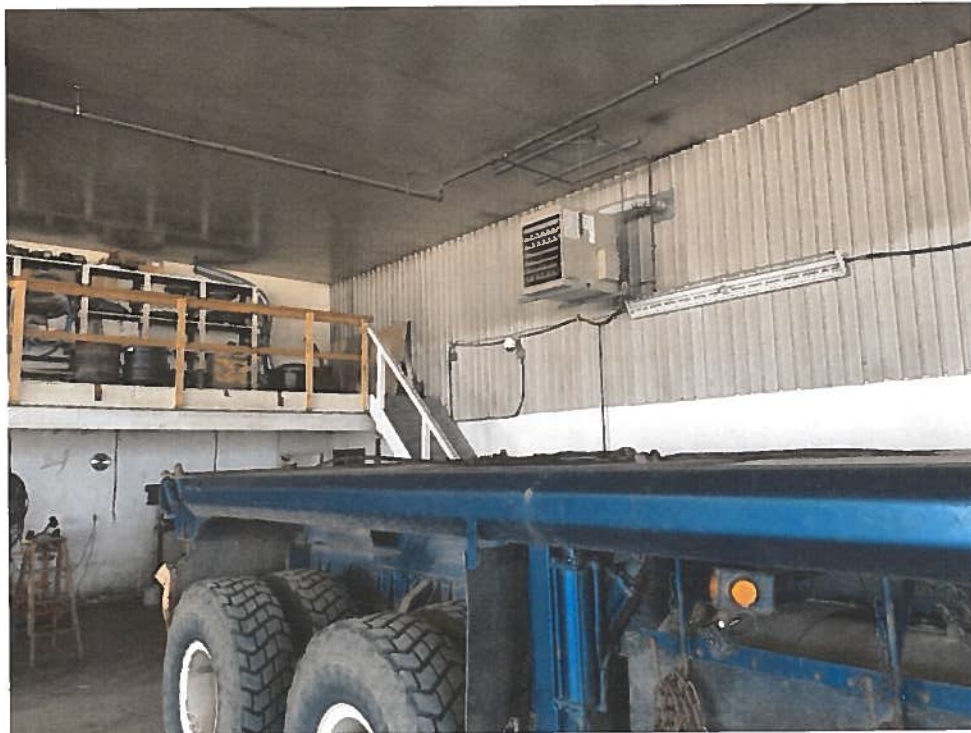
FIGURE 13: SHOP HEATING UNITS

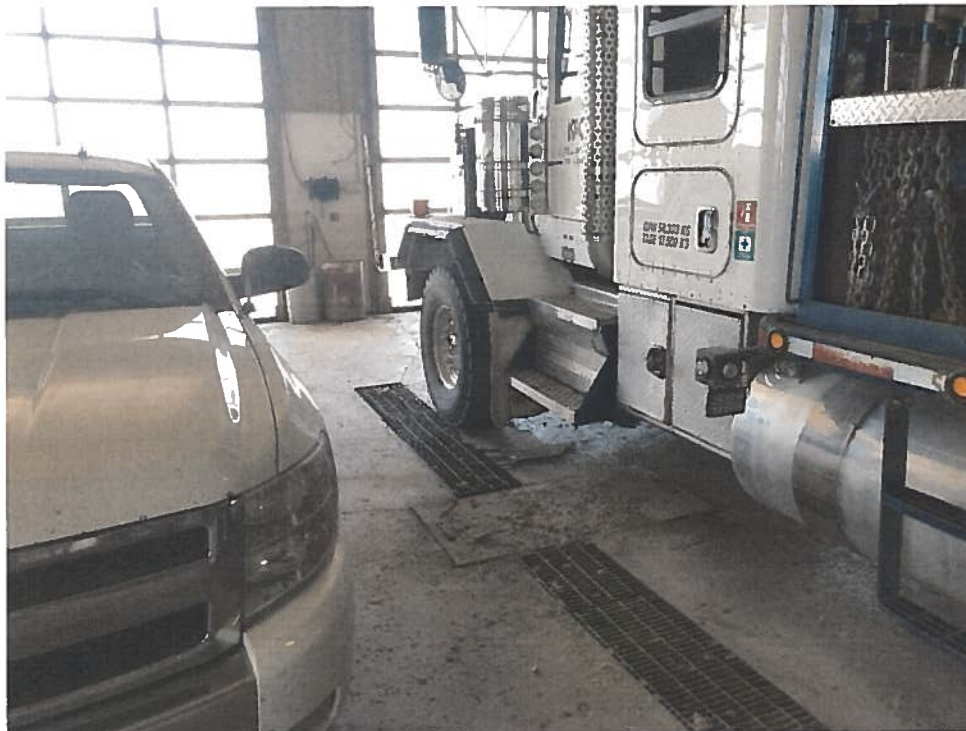
FIGURE 15: SUMP IN SHOP AREA

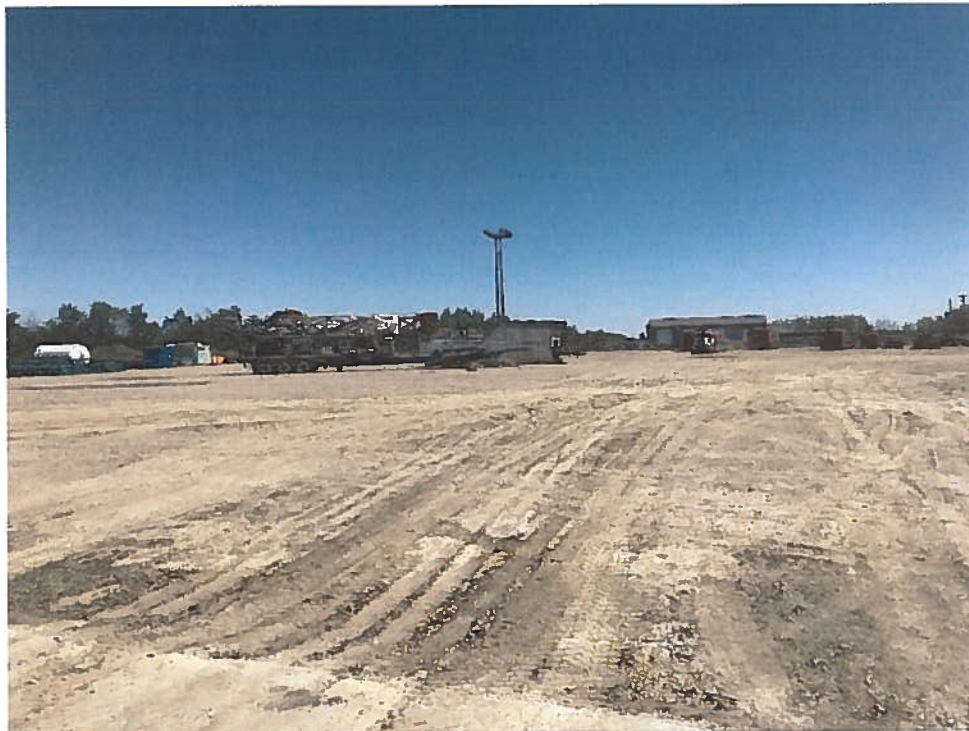
- Dumping or Fill
No dumping or fill material was noted on the subject property other than the gravel that had been brought to site for the storage yard.

FIGURE 17: GRAVEL STORAGE YARD

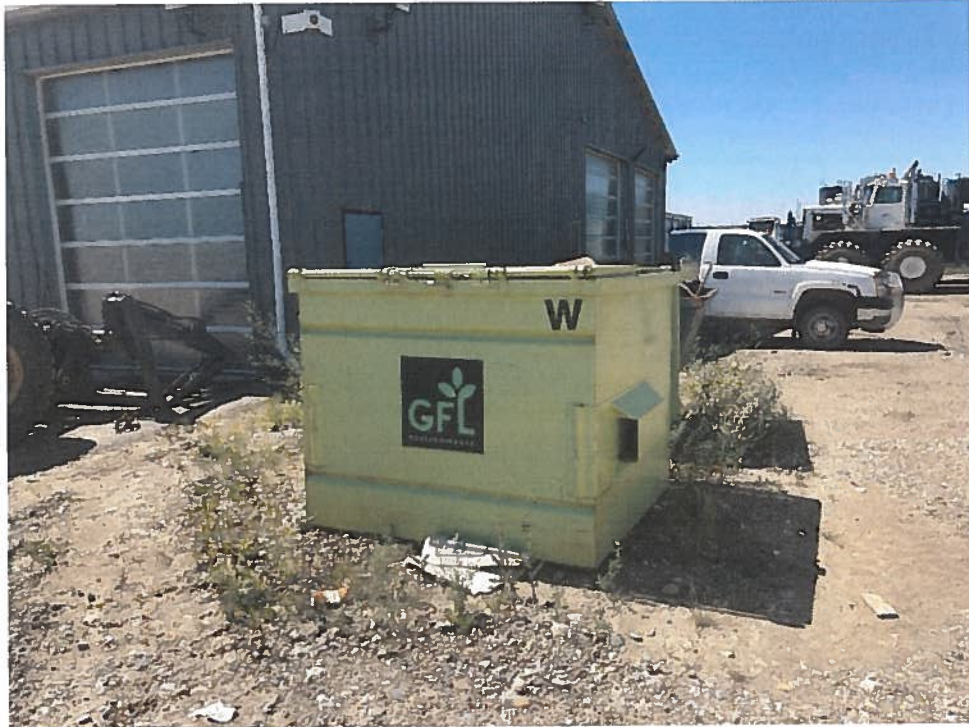
- Sewage Disposal System
Sewer service is supplied from an onsite septic tank system.
- Solid Waste
Solid waste is collected in bins and disposed of as required.

FIGURE 18: SOLID WASTE DISPOSAL

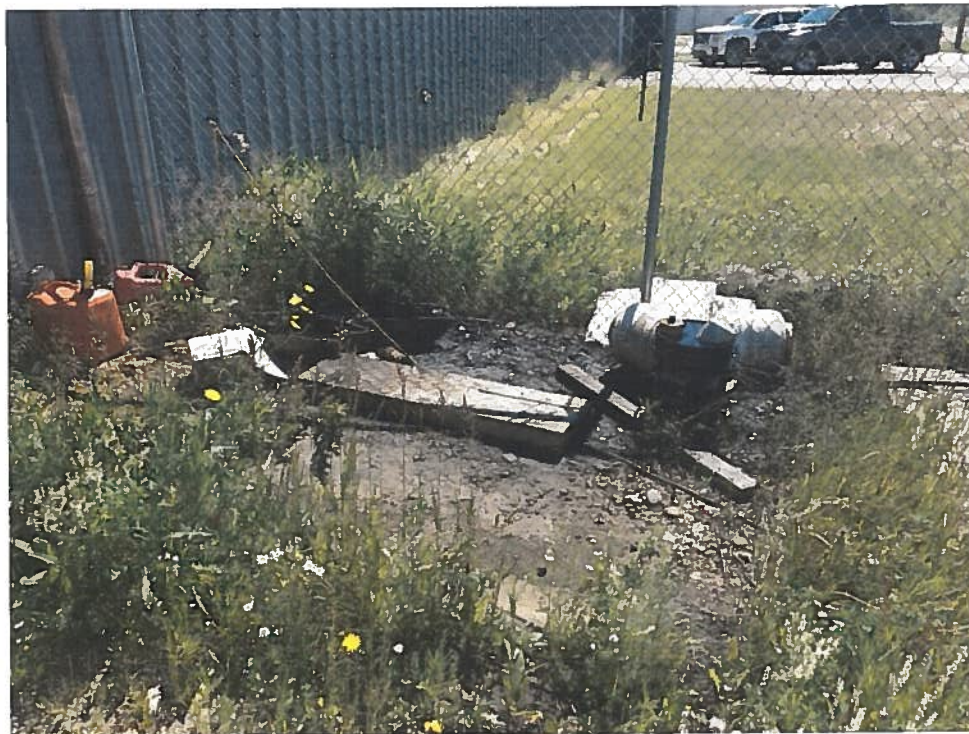
- Discolored Soils/Stressed Vegetation
During the site visit no discolored soils or stressed vegetation was noted.
- Stained Surfaces
Some minor stained surfaces on the concrete aprons and a small section along the northwest corner of the building were observed. These stained areas appeared to be surficial in nature and are recommended to be cleaned up as required. Penetration of the contamination into the subsurface was not observed.

FIGURE 19: SURFICIAL STAINING ALONG WEST BUILDING EXTERIOR

1. We observed no evidence of significant surface staining or contamination of the site area that would warrant further assessment and/or testing of the sub base soils at this property. It is recommended that the noted stained area at the northwest exterior corner of the building be cleaned up and disposed of accordingly.

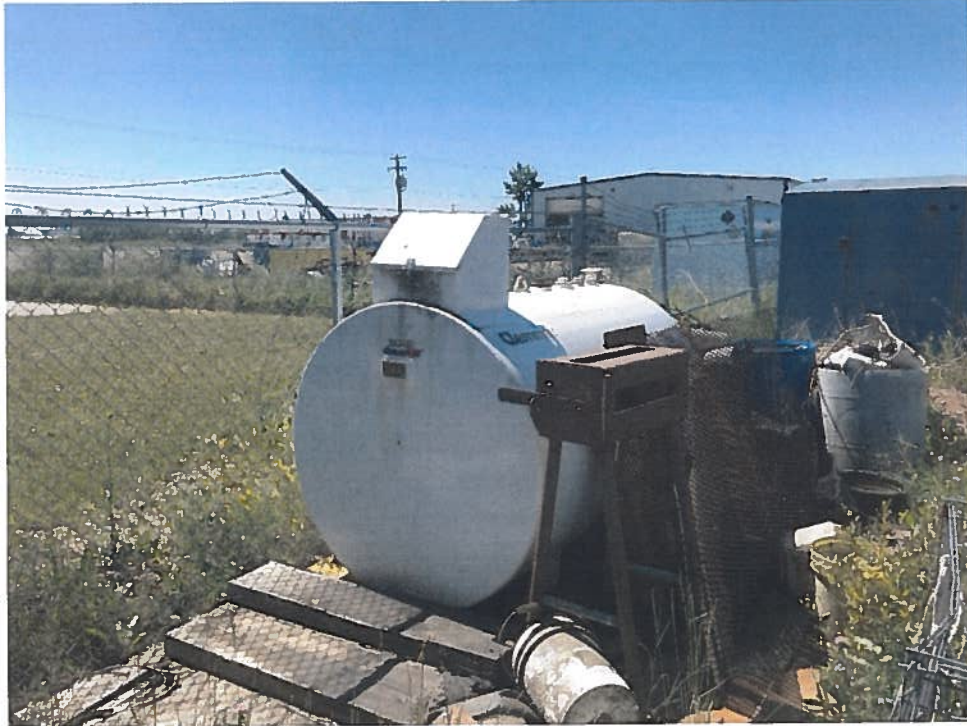
- Above Ground Storage Tanks (AST's)
An above ground waste oil tank was noted on the subject property. It was currently not in use and appeared to be in good working condition with no signs of leaks or contamination.

FIGURE 20: EMPTY WASTE OIL TANK

2. It is recommended that any empty drums, tanks, and waste materials that are currently situated on the property be removed and disposed of if possible to ensure no future environmental concerns arise.

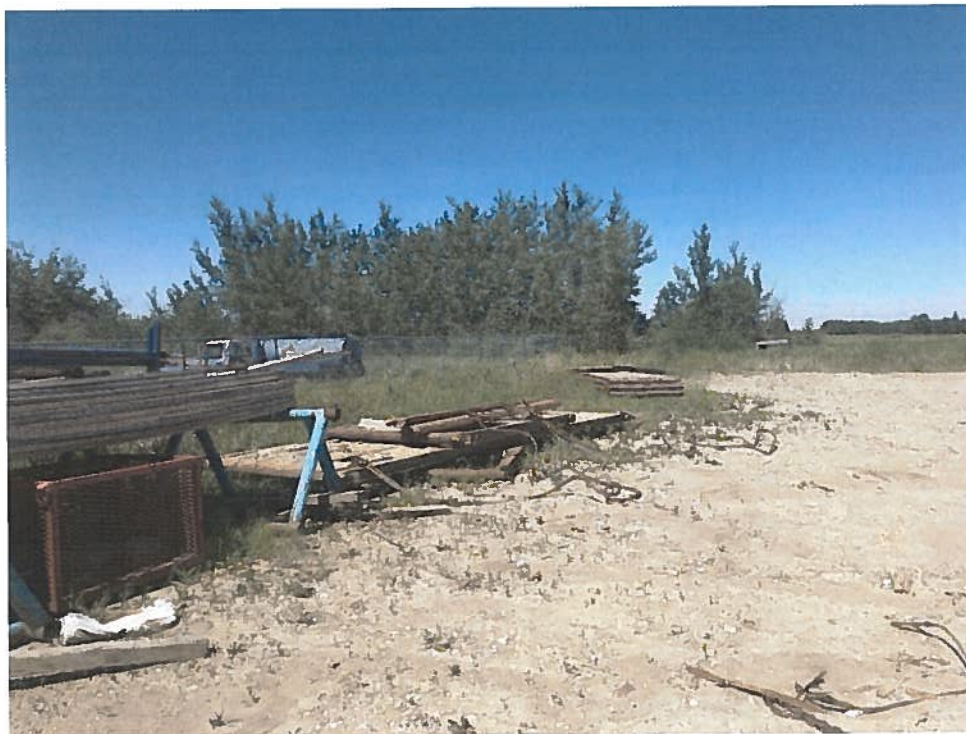
- Drums and Other Containers
Several empty drums and containers were noted on the subject property. They were all clearly labeled with no signs of leaks or contamination.

FIGURE 21: MISCELLANEOUS STORAGE MATERIAL

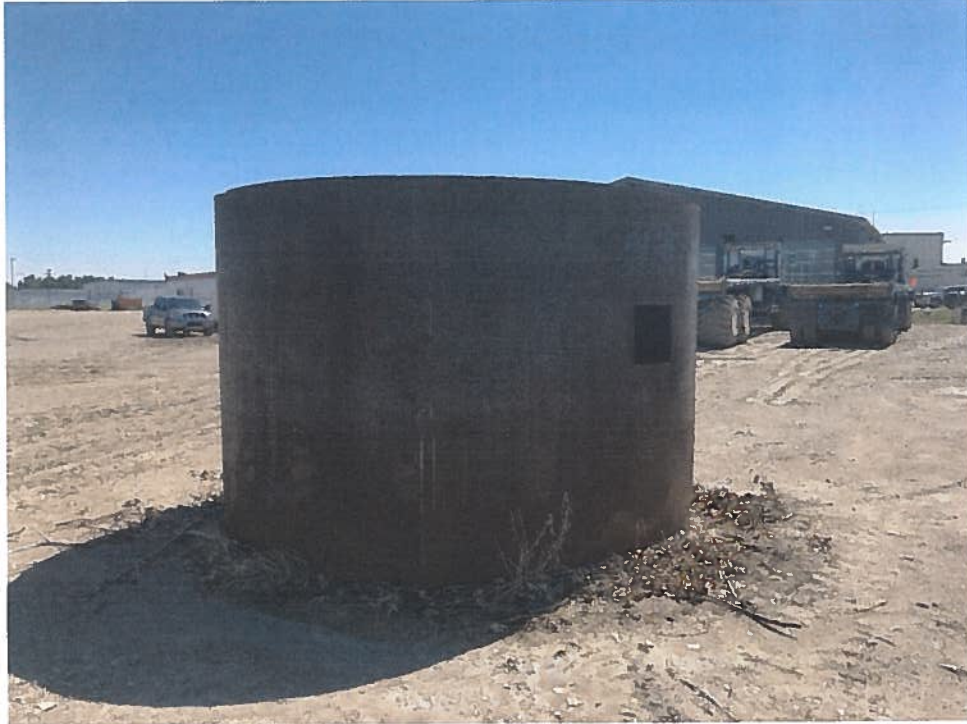
FIGURE 22: BURN BARREL

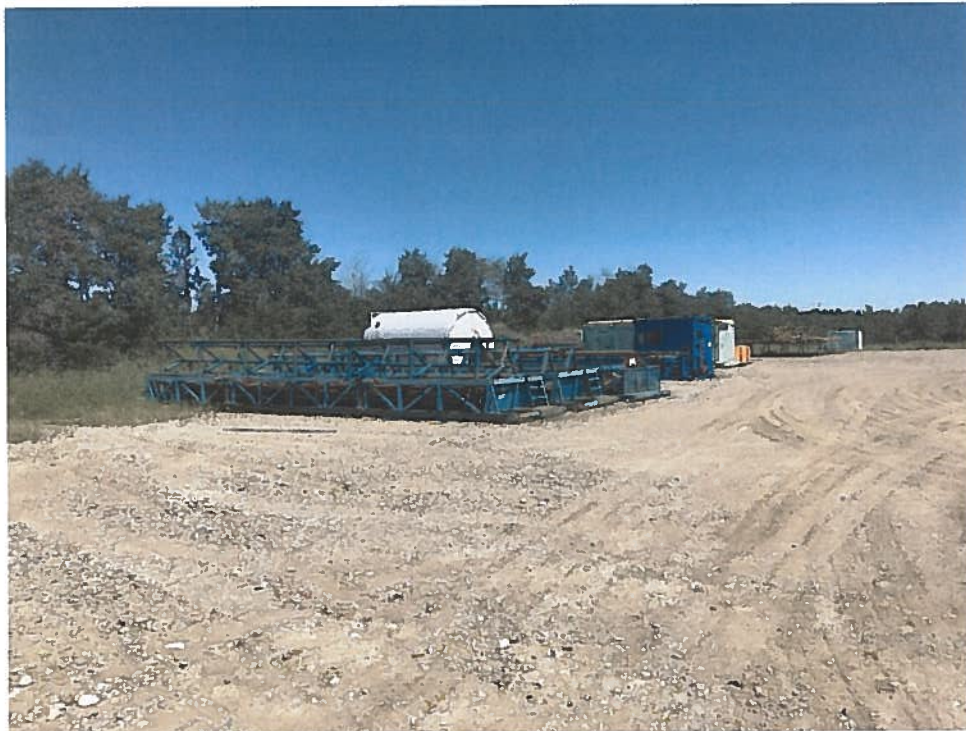
FIGURE 23: MISCELLANEOUS STORAGE MATERIAL

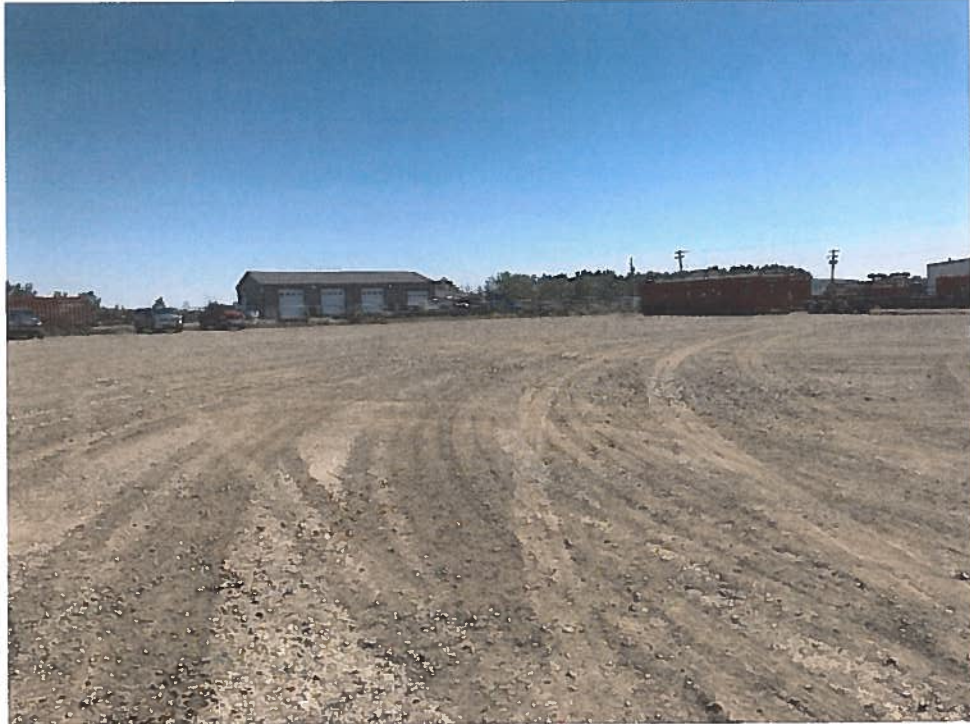
FIGURE 24: GRAVEL STORAGE YARD
